Reference: 611011

May 8, 2012

Subject: Geotechnical Evaluation, Coos Bay Public Library, Coos Bay, Oregon

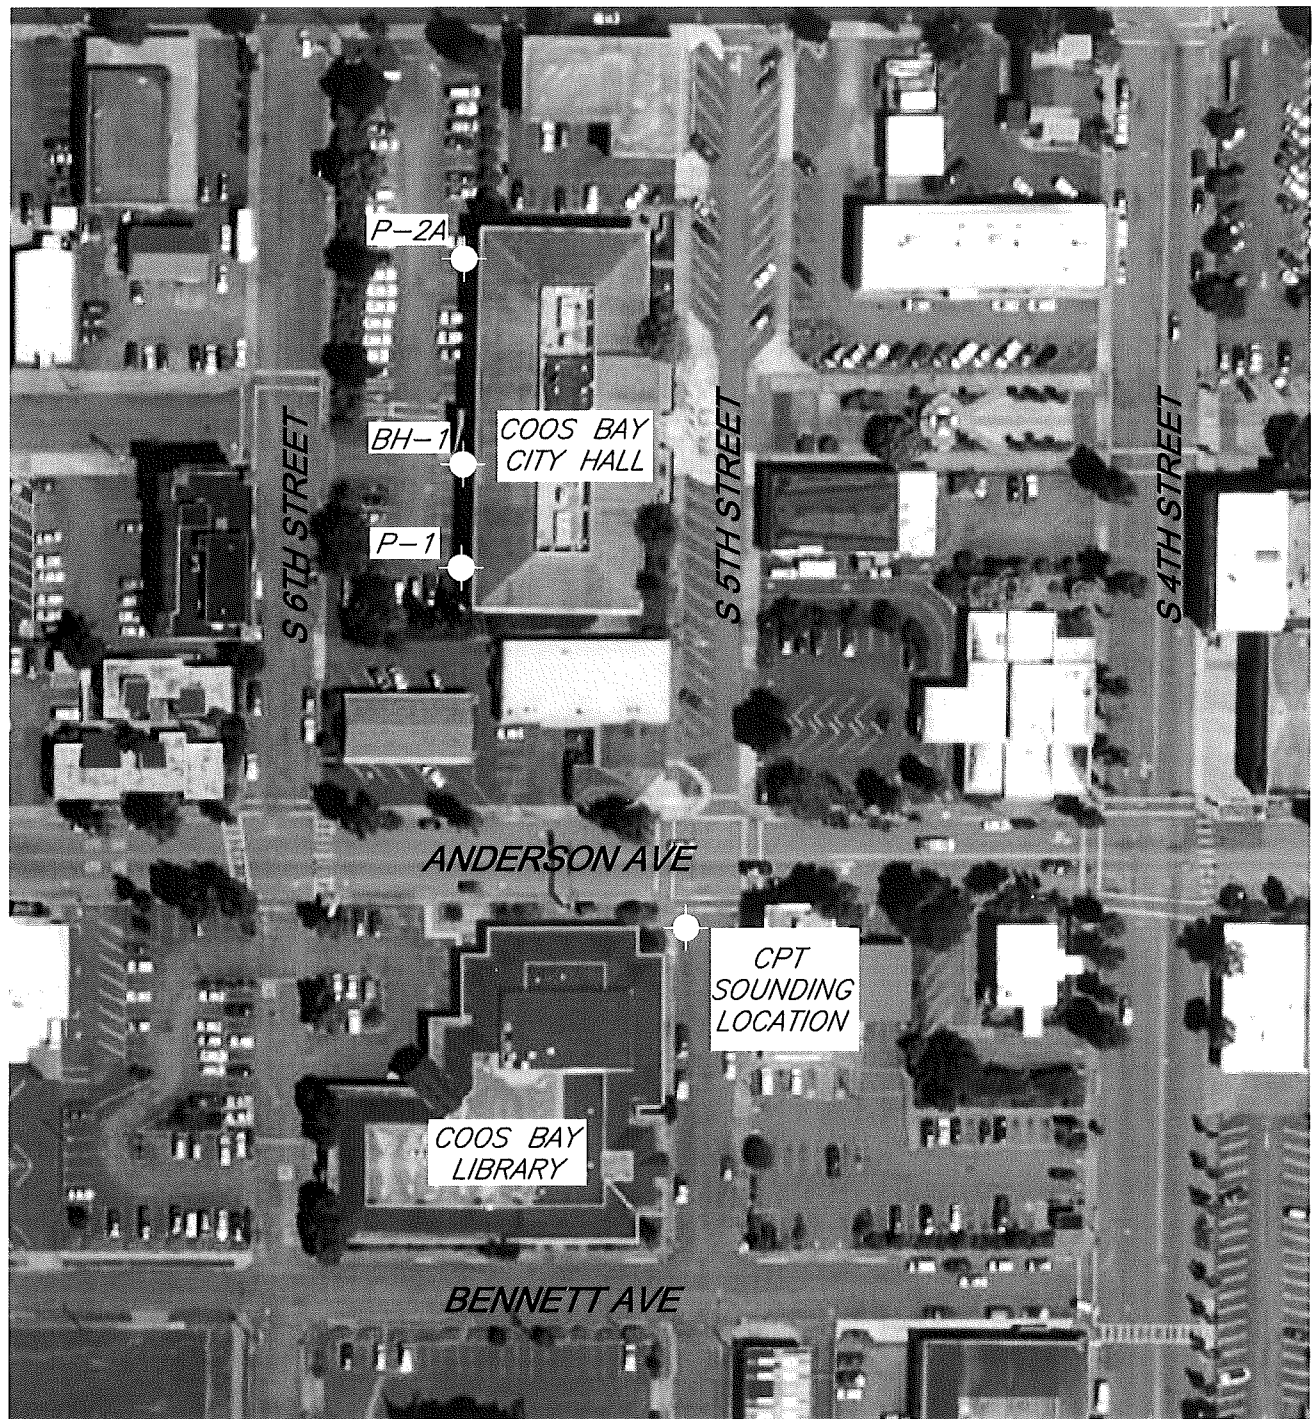
A geologist from SHN conducted a field investigation at the subject site on April 6, 2012. We supervised one Cone Penetration Test (CPT) sounding near the northeast corner of the library (Figure 1 included in Attachment 1). The CPT sounding was performed to obtain a nearly continuous profile of the specific engineering properties of the soils and to compare them to those encountered at City Hall, about 350 feet to the north. SHN conducted a geotechnical evaluation of the subsurface conditions and existing piles at the City Hall, where foundations consisted of 12-inch diameter timber piles that were driven 80 feet. Reported pile capacity for design was 20 tons (SHN, May 26, 2011).

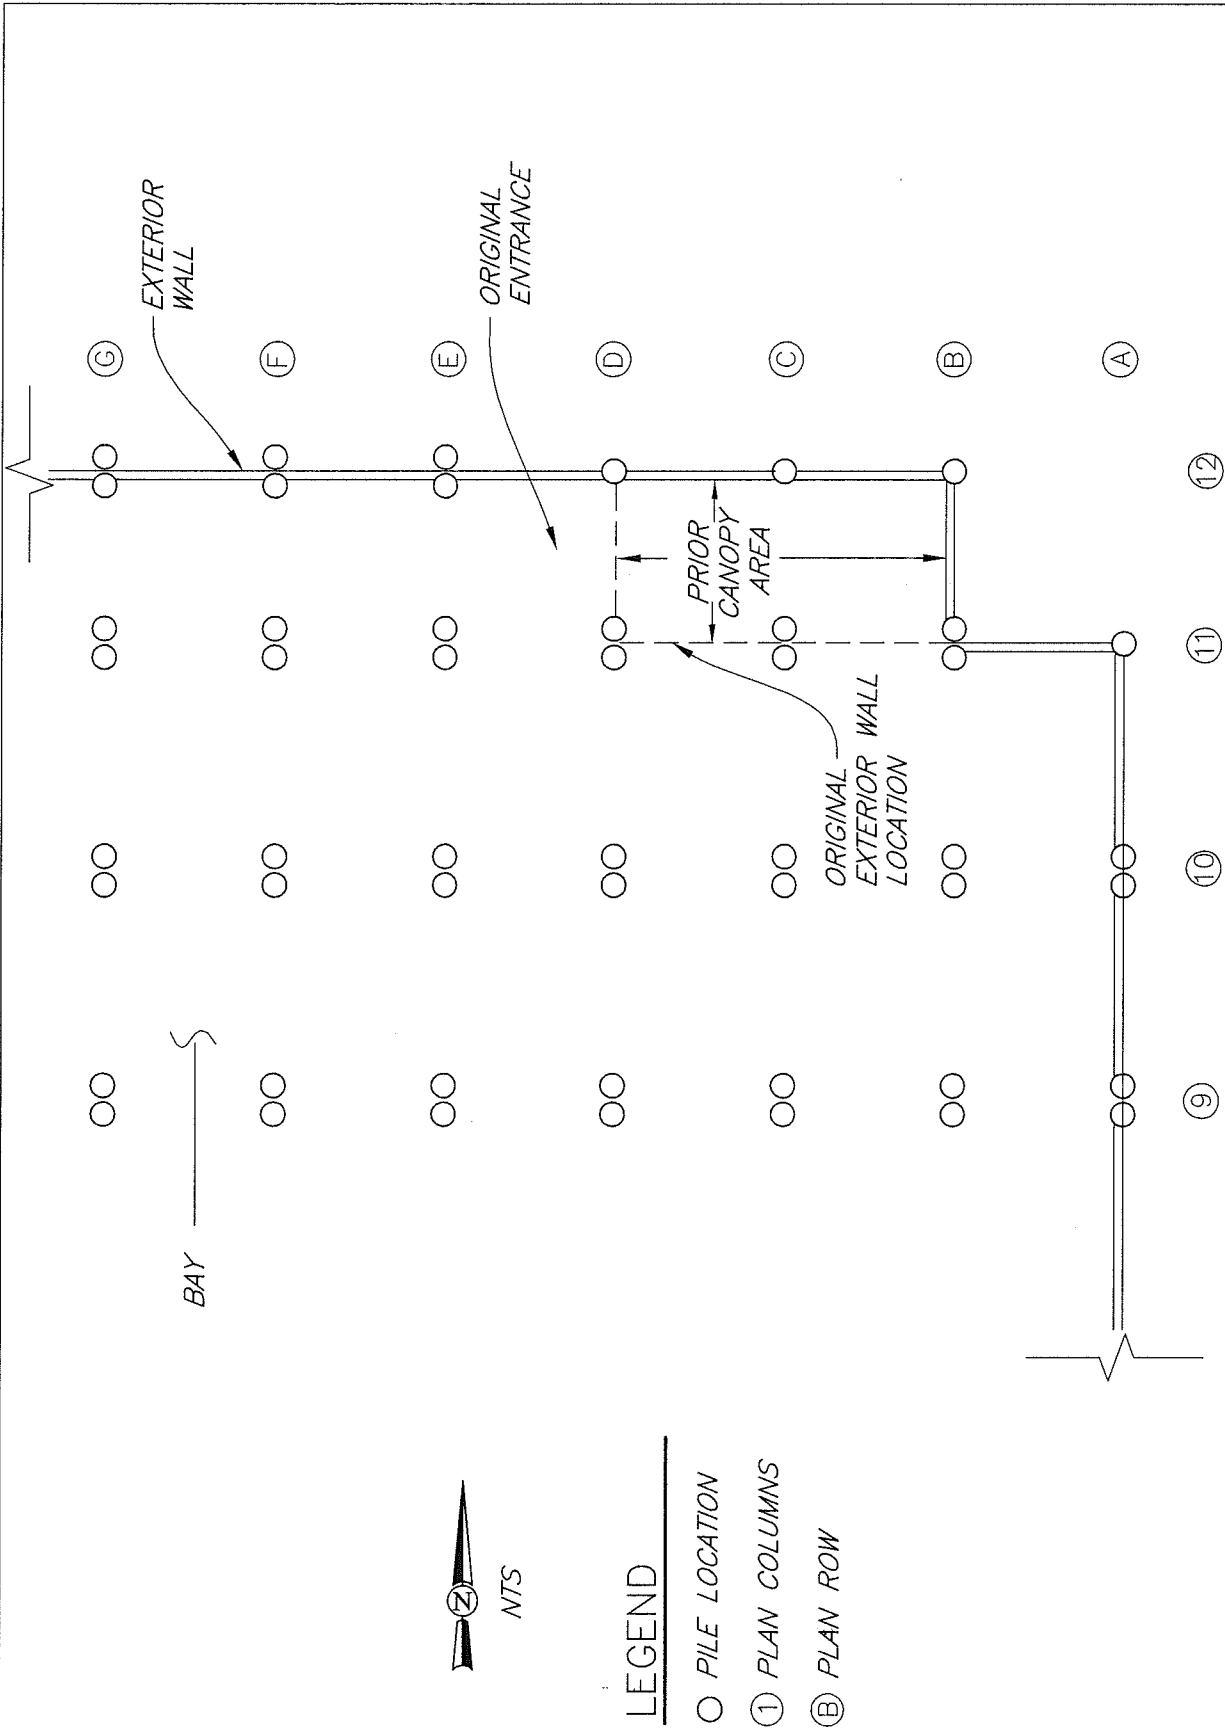
Figure 2

The library structure was designed and constructed in 1965. Plans for the Library and Civic Center Facility were prepared by Kruse & Fitch, Architects. Drawing 2 of 20 (See Attachment 2) shows the foundation layout, consisting of 12 plan columns (PC1 through PC12, south to north) and 8 plan rows (PR-A through PR-H, east to west) on 16-foot centers. Each area between plan columns and rows is called a bay (Figure 2 included in Attachment 1). The original entrance to the library was on the north side, between PC11 and PC12, PR-D and PR-E. Two bays to the west (PC11 and PC12, PR-E through -G) were enclosed as part of the original library floor space. Two bays to the east (PC11 and PC12, PR-B through -D) were not enclosed and were covered by the entry canopy.

Nearly all perimeter foundations consisted of a two-pile cap (two foundations were designed with a 3-pile cap). The building corners at 6H¹, 11H, and 11A have single-pile support. The canopy-support columns at 12B, 12C, and 12D along the present north wall, are also supported by single piles. Foundations consist of 12-inch diameter timber piles, 45 to 50 feet long. Piles along PC1 and PC2 were designed to be 45 feet long; all other piles were to be 50 feet long. Interior columns are configured in 2- to 5-pile groups. Individual or group pile capacities could not be found on the plans.

Based on the review of plans, the distress, and present conditions, our preliminary conclusion was that nearly all of the distress is due to inadequate pile capacities along the northeastern wall (PC12). The foundations that supported the canopy are single piles, extending to a depth of 50 feet. All other perimeter footing foundations consist of two piles, except at three corners. We found no plans that indicated additional piles were planned to support the new walls and roof loads. Therefore, we concluded that the columns at 12B, 12C, and 12D have inadequate foundations.

Based on the above assumptions and reasoning, it is likely that the single piles for perimeter building columns at 12B, 12C, and 12D are not providing adequate support for the intended design loads. Following the Kruse & Fitch design, these columns should be supported by a 2-pile group with a total allowable pile capacity of 25 tons.

The most obvious remediation measure is to provide additional foundation support for the three columns in question, where single piles supported the original canopy. This can be achieved in many different ways, although the most practical includes the use of multiple micro-piles that can be drilled adjacent to and surrounding the existing single-pile caps on the exterior. Friction-only support can be estimated based on the analysis in this report. Additional foundation support can also be measured by drilling equipment that has the capability of making that determination by resistance during installation.

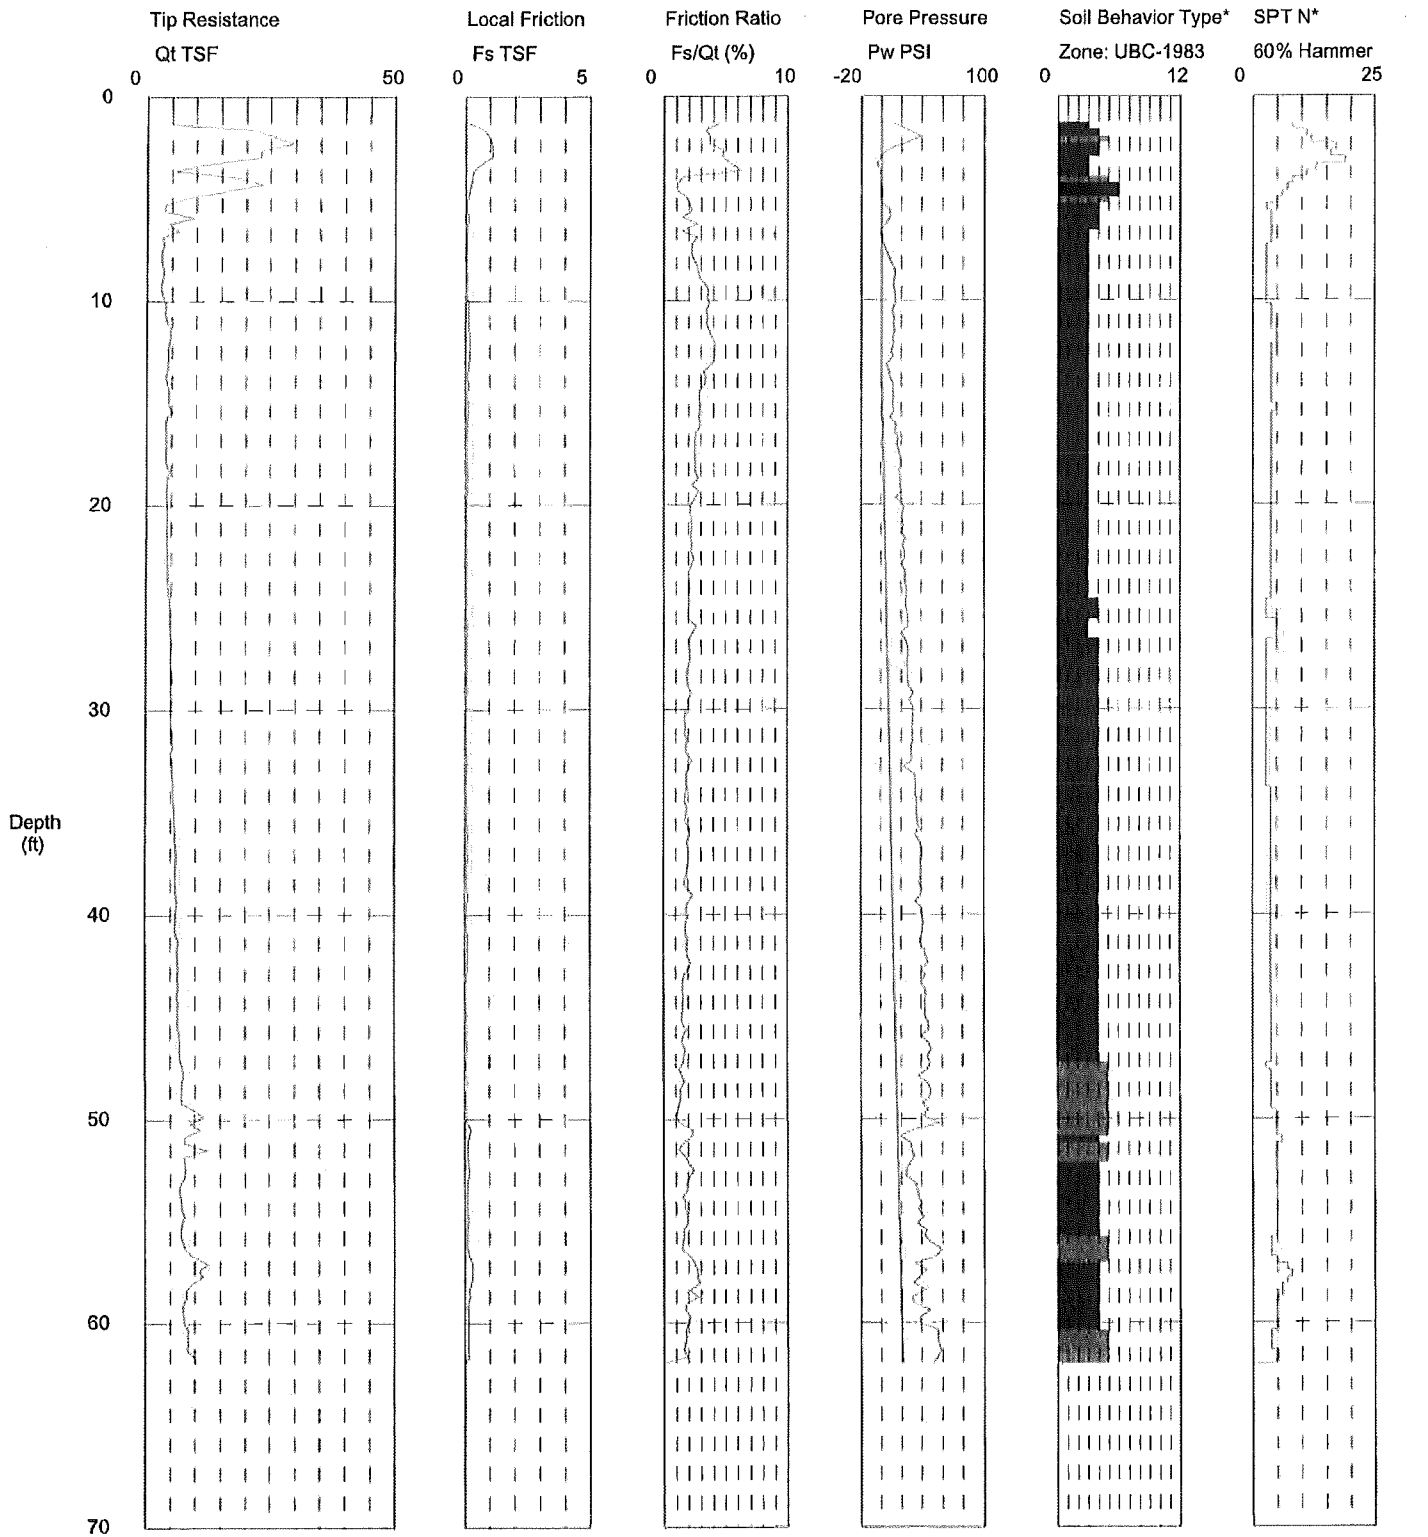
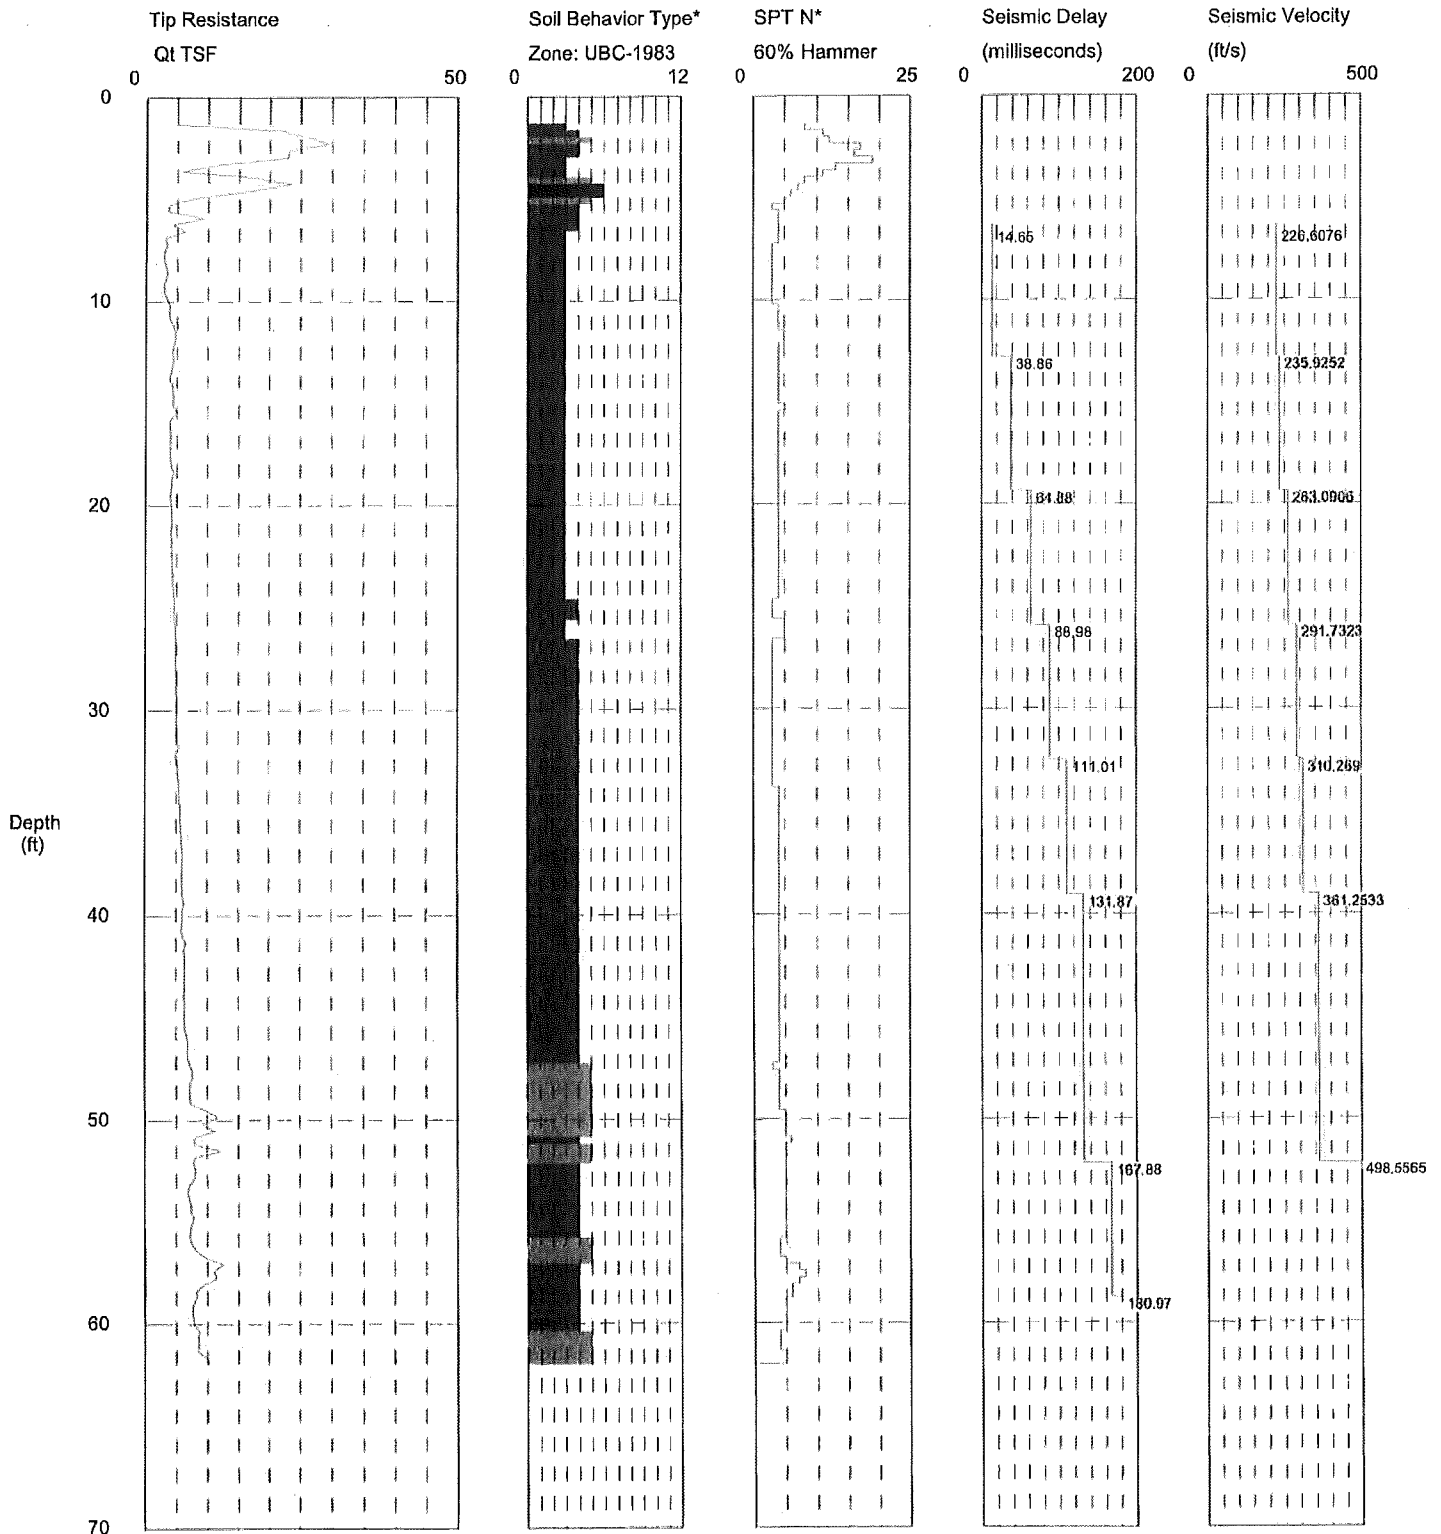
Operator: SAM
Sounding: CPT-1
Cone Used: DSG0457

In general, subsurface soil conditions at the library are comparable to conditions encountered at City Hall: highly plastic silt to a depth of at least 60 feet (110 feet at City Hall), identified as MH using the Unified Soil Classification System. This silt is highly compressible, having high moisture content and low dry density. The average soil data and engineering properties are summarized in Table 1 on the following page.
