CITY OF COOS BAY CITY COUNCIL
Agenda Staff Report

MEETING DATE July 7, 2015	AGENDA ITEM NUMBER
-------------------------------------	---------------------------

ISSUE: Continuation of Consideration of Approval for the Wastewater Treatment Plant No. 2 Outfall Repair

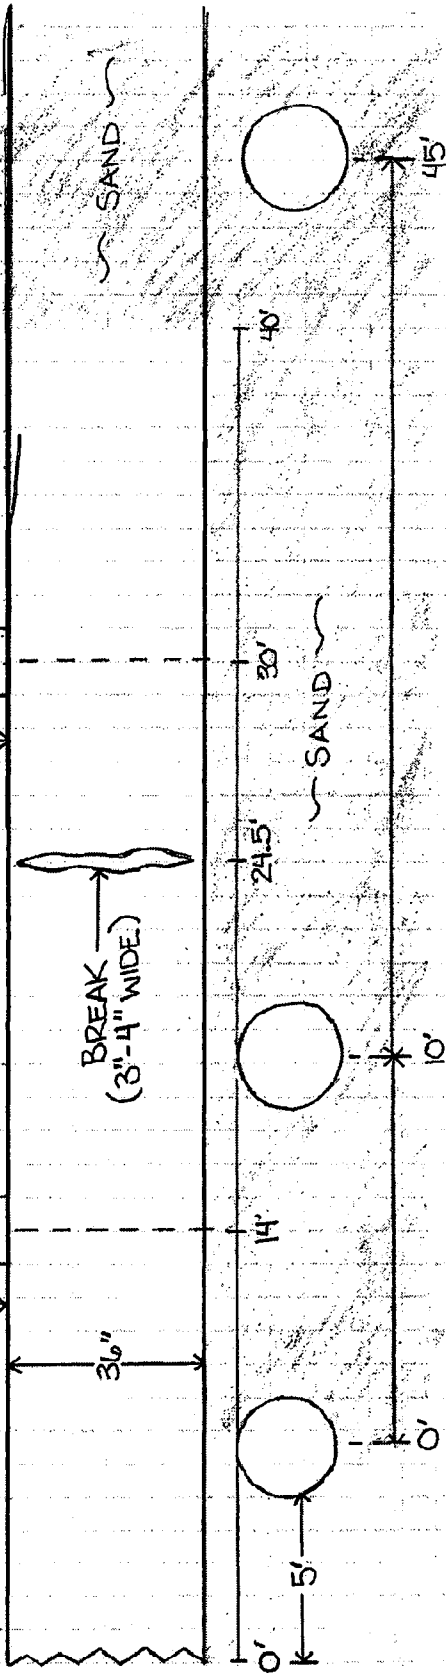
PLAN VIEW
NOT TO SCALE

In 2014, City Staff, as a part of City's NPDES permit renewal process, agreed with DEQ to have a mixing zone analysis performed for the outfall that serves Wastewater Treatment Plant No. 2. The City contracted with CH2M HILL to perform the analysis under the miscellaneous engineering services contract. Originally, it was assumed that the analysis would be based on the outfall diffuser configuration as observed in a dive report performed in 2009 and the 1975 Record Drawings (It is believed that construction commenced in 1973). However, further analysis of the as-built information and the 2009 dive report yielded inconsistencies between the two. It was concluded that for the purposes of modeling an accurate mixing zone that a new dive inspection should be performed. The new 2015 dive report identified significant deterioration of the outfall since the 2009 investigation. The outfall was constructed with five diffusers at the end of the pipe that introduce the treated effluent into the bay and establish the dilution rates. The dive investigation determined that two of these ports are silted up, two are damaged, and one has broken off. In addition, there is a 3-4 inch gap in the top of the pipe near the end of the outfall.

Existing WWTP2 Outfall Diffuser Condition (2015)

DIFFUSER

EXISTING
PILES

BREAK
(3'-4" WIDE)

SAND

Staff immediately contacted DEQ to inform them of the deteriorated outfall and to work with them on a solution. Staff also coordinated with CH2M HILL on the results of the dive investigation. After two conference calls with City staff, DEQ, and CH2M HILL it was recommended that an interim fix be performed on the diffuser until and ultimate fix can be designed, permitted, funded, and constructed.

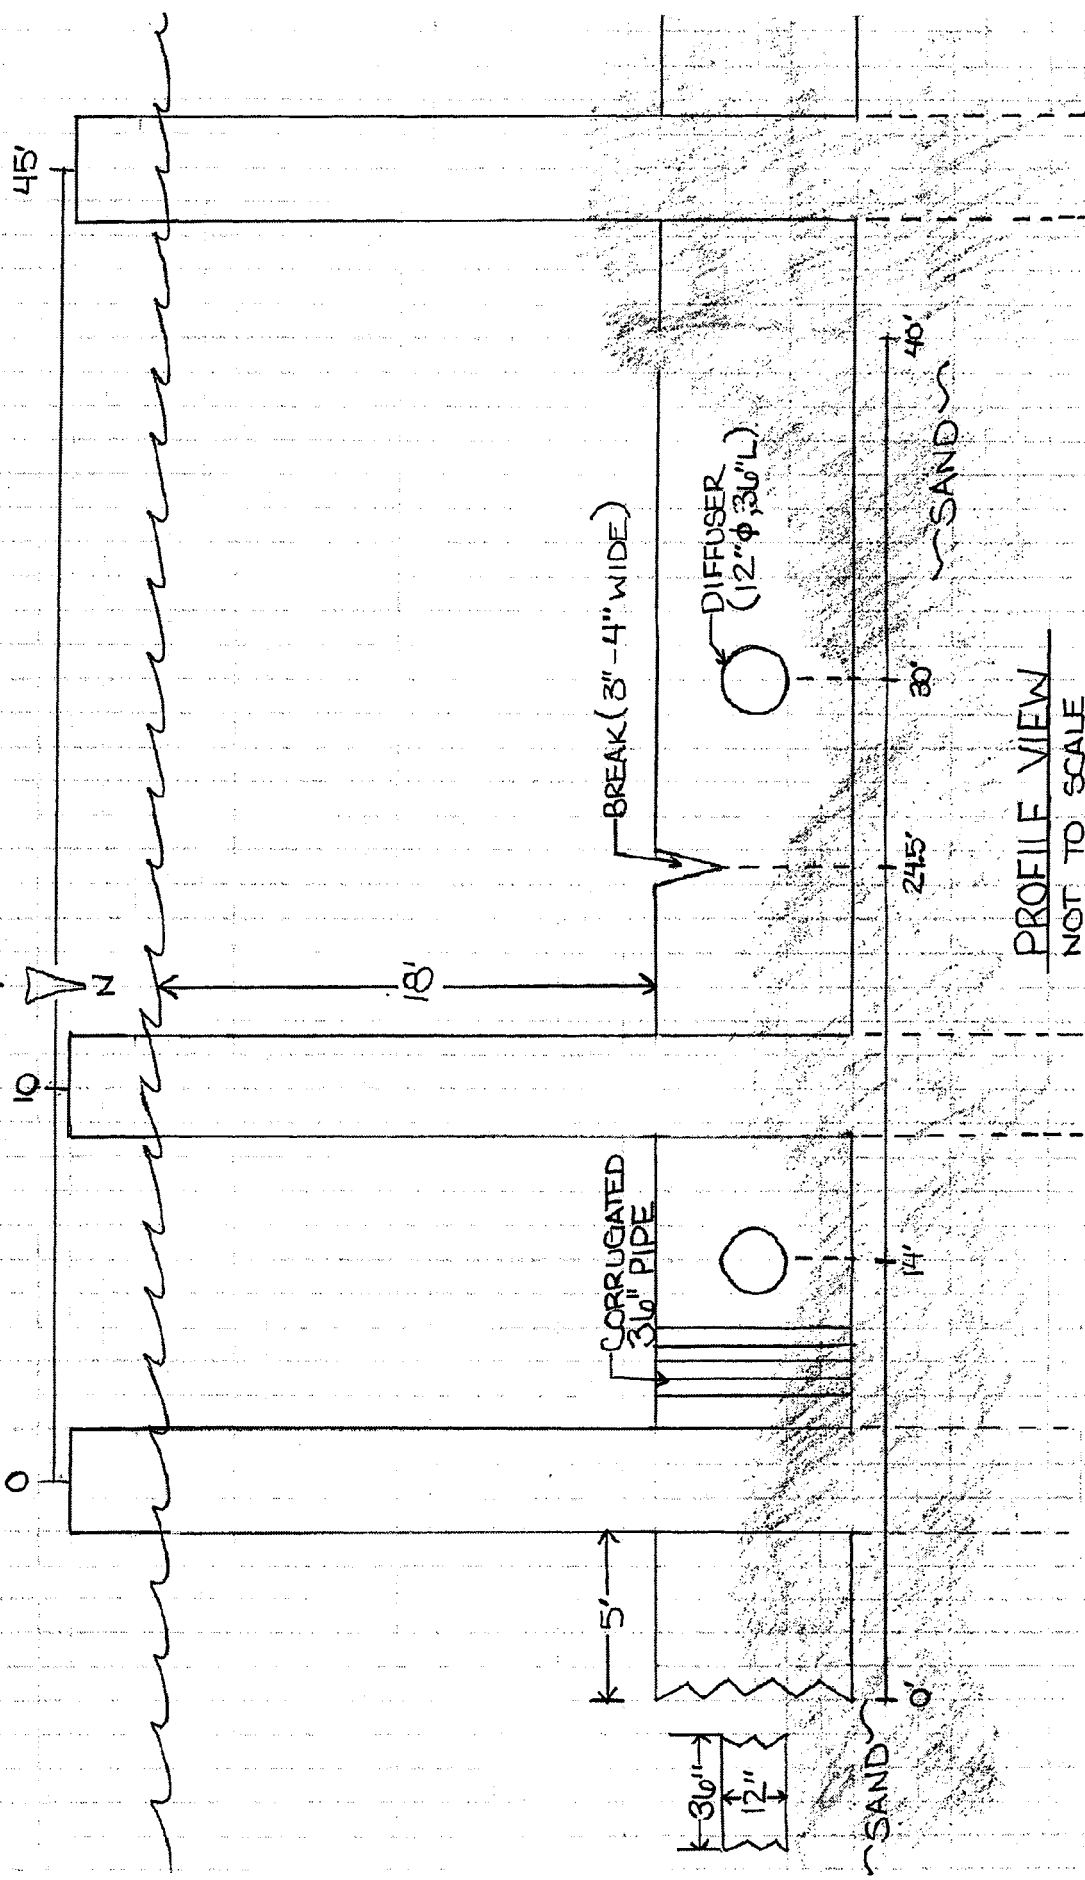
PROFILE VIEW
NOT TO SCALE

Existing WWTP2 Outfall Diffuser
Condition (2015)

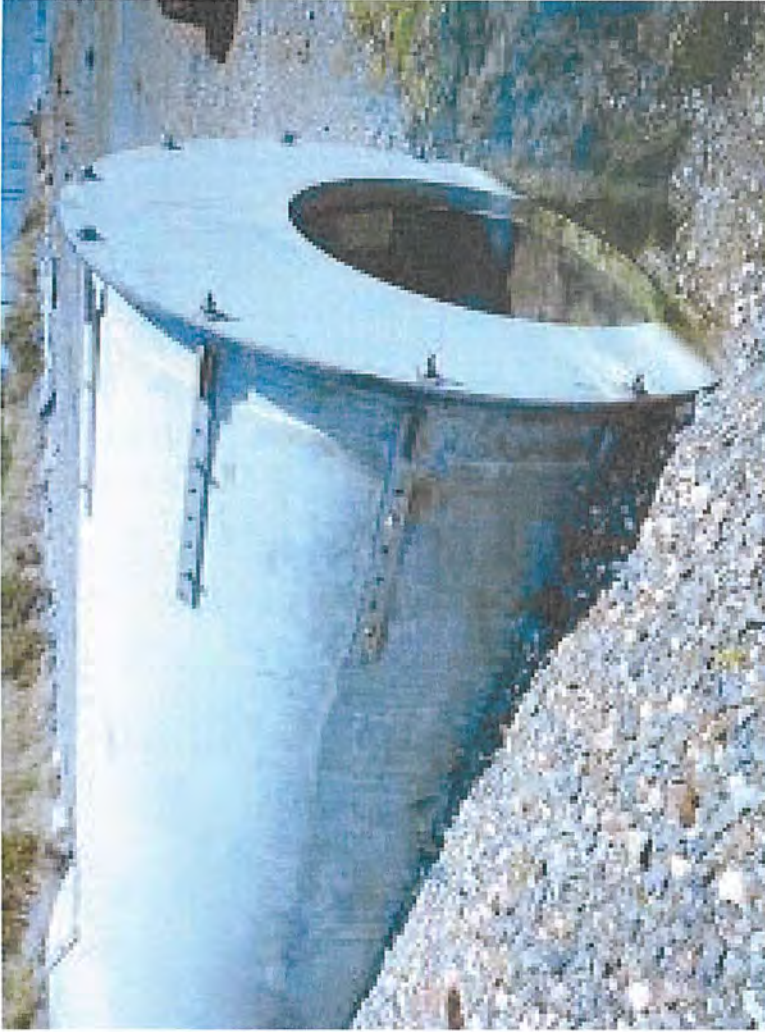
Example of what west end of the diffuser looks like.
