**City of Coos Bay**  
**Coos County, Oregon**

# STORM WATER MASTER PLAN

SEPTEMBER 2004

Project No. 109.07

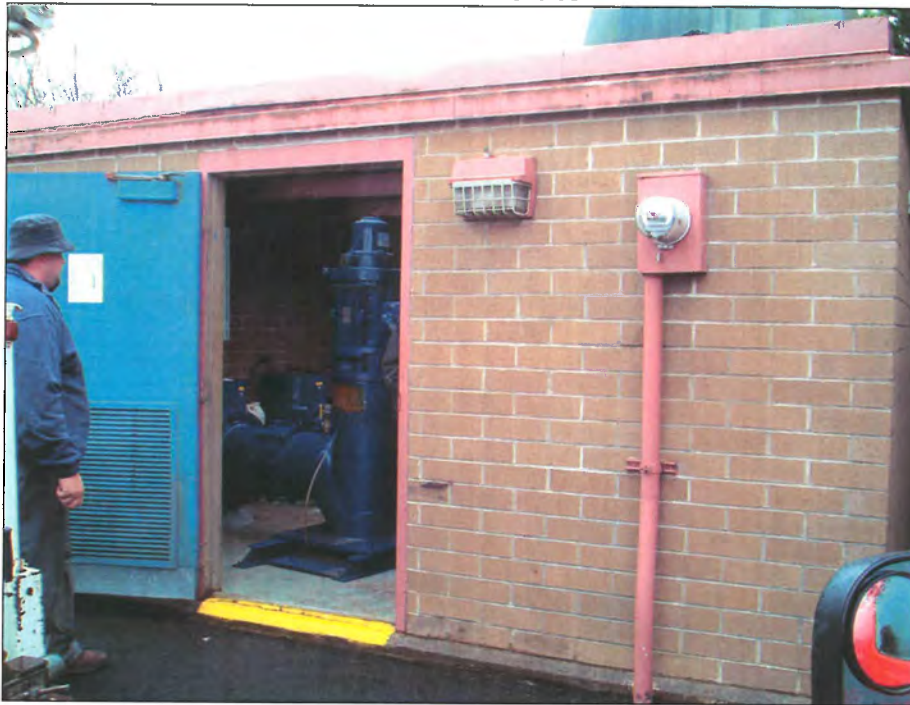
**FIGURE 3.2.1  
PUMP STATION 15**

The station has a brick pump house located over the wetwell, housing three Byron Jackson pumps. The two 15 HP pumps were replaced last year and had soft start motor controls added this year. The 30 HP pump was rebuilt two years ago, and also had a soft start added. A 75 kW Onan generator provides backup power. While no deficiencies were noted for the pump station, leakage in the pressurized vault has eroded soils around the vault access, and water sprays through gaps in the concrete when the pumps are activated. A photograph of this station is included in Figure 3.2.1 and the operating parameters are detailed in Table 3.2.5.

each pump would be a time consuming process, and would require a large amount of dye to be discharged to the Bay. As the two 15-HP pumps are new and the maintenance crew feels that the larger pump operates satisfactorily, no further attempts were made to verify capacity.

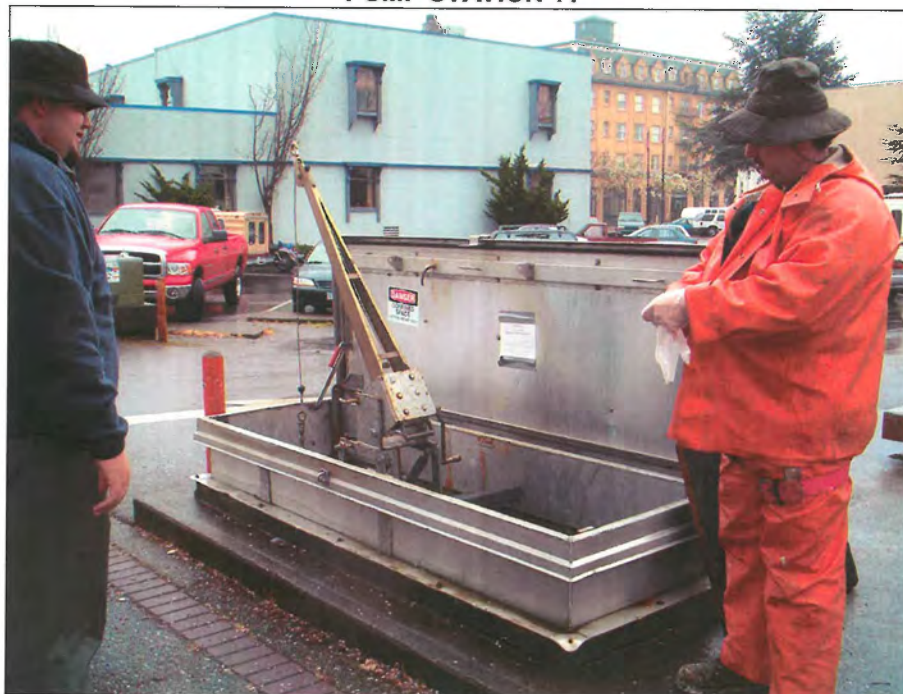
**FIGURE 3.2.2  
PUMP STATION 11**

Tidebox 15 is located at 3<sup>rd</sup> Street and Commercial Avenue adjacent to Pump Station 11. Two tidegates are located in the box, a 12-inch and a 24-inch diameter flapper gate. The gates are sited to prevent backflow to the upper reaches of the gravity storm system when the pump station is activated. The gates appear to be in good condition.
