CITY OF COOS BAY CITY COUNCIL
Agenda Staff Report

ISSUE: Rockwall & Railing along North 12th Street

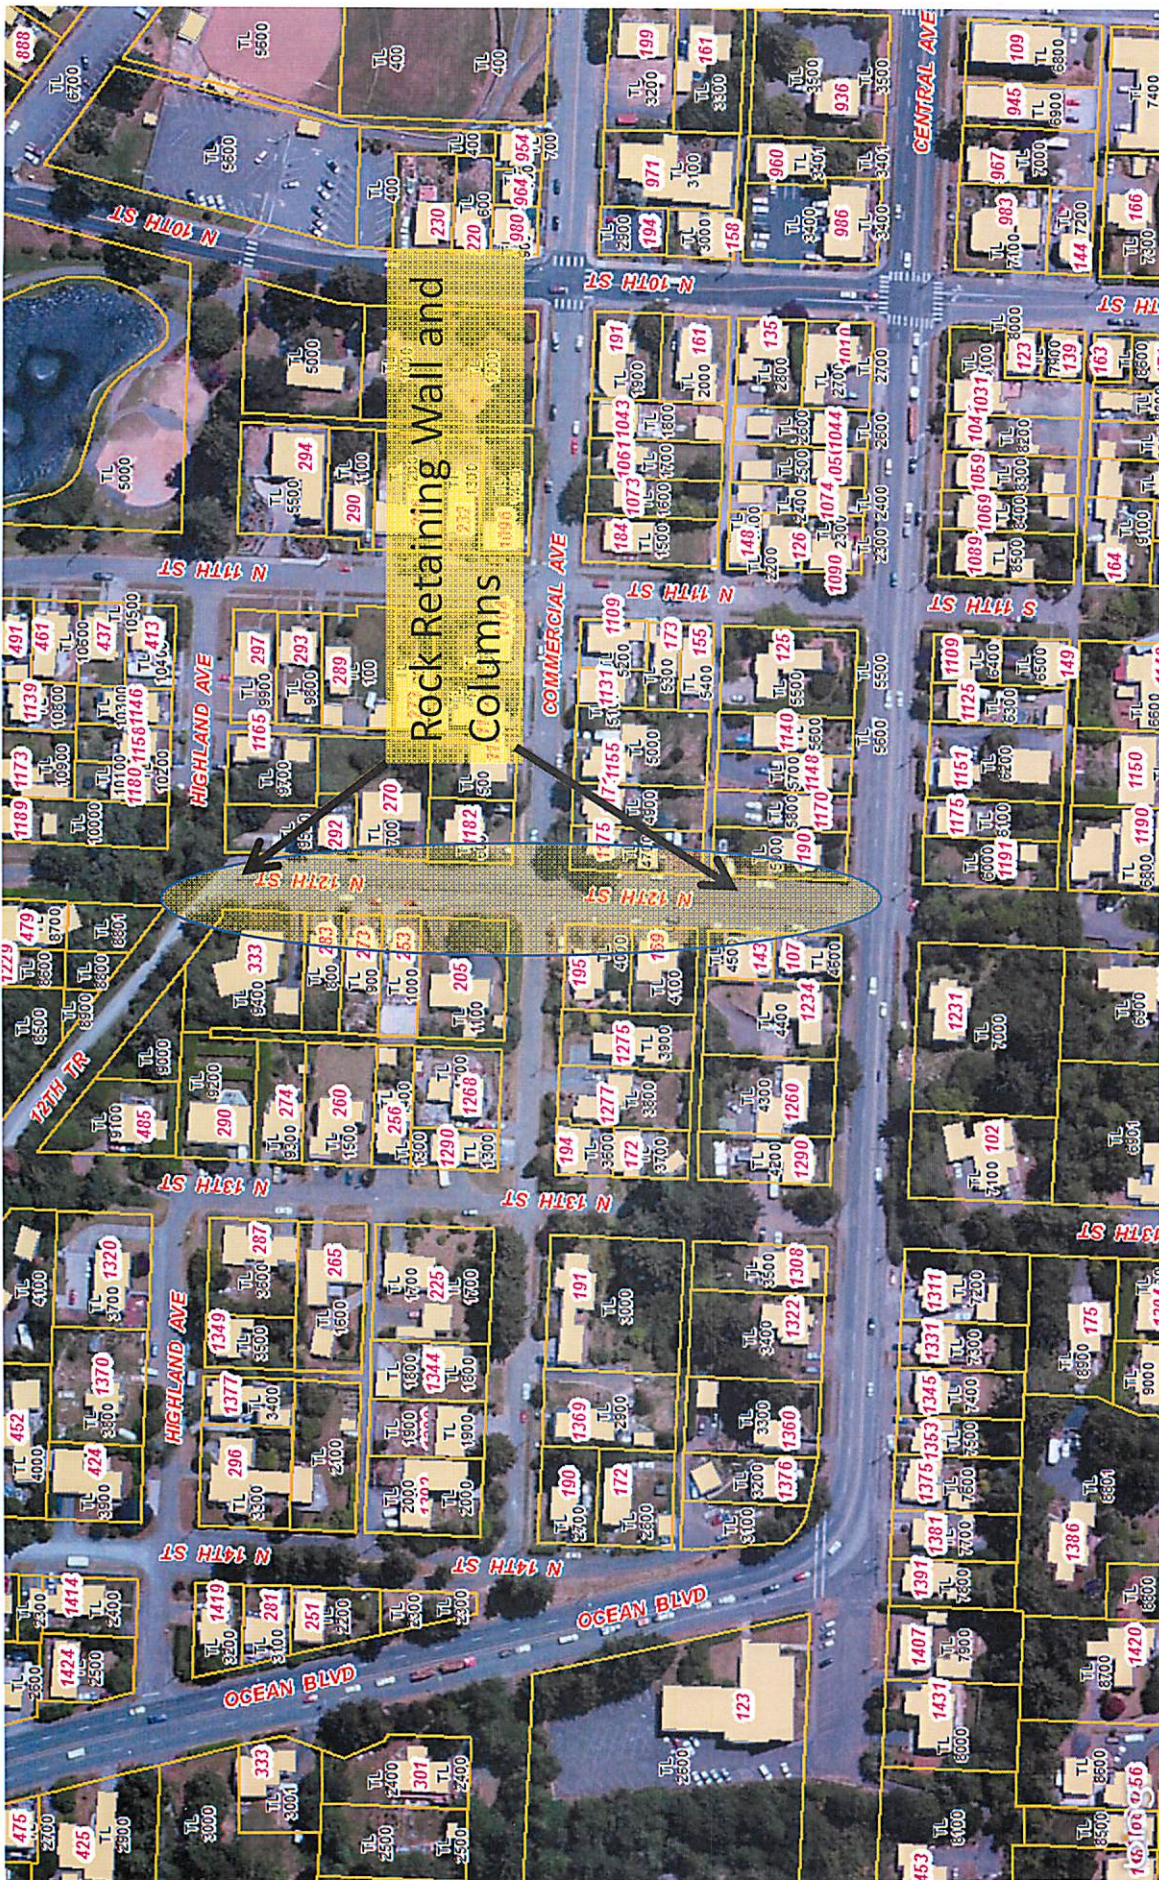
Last month, Councilor Muenchrath said he had heard from a citizen concerned with the condition of the railing at the top of the retaining rock wall along and between upper and lower 12th Street. The wall is along the portion of 12th Street north of Central Avenue. City staff investigated the rock wall and decorative rock columns along with the metal tube rail between columns. No plans exist to tell us how or when the retaining wall was constructed. Our best guess is the wall was constructed around 80 to 100 years ago. Without performing a subsurface geotechnical investigation on the rock wall, it appears the wall is in sound condition. However the rail and columns on top of the wall show signs of deterioration.

Rock Retaining Wall and Columns

While the existing rock column and metal rail system does not meet modern guardrail design standards, there have not been a significant number of accidents involving it. Ideally, the existing rock column and metal rail system should be replaced with a guardrail meeting modern design standards. Limited funds this fiscal year means other, perhaps higher priority, maintenance projects would have to be postponed to complete this replacement project. Staff recommends that this project be considered through the upcoming FYE 2014 budget planning/approval process. During this process this project can be prioritized against other projects for the limited available funds.

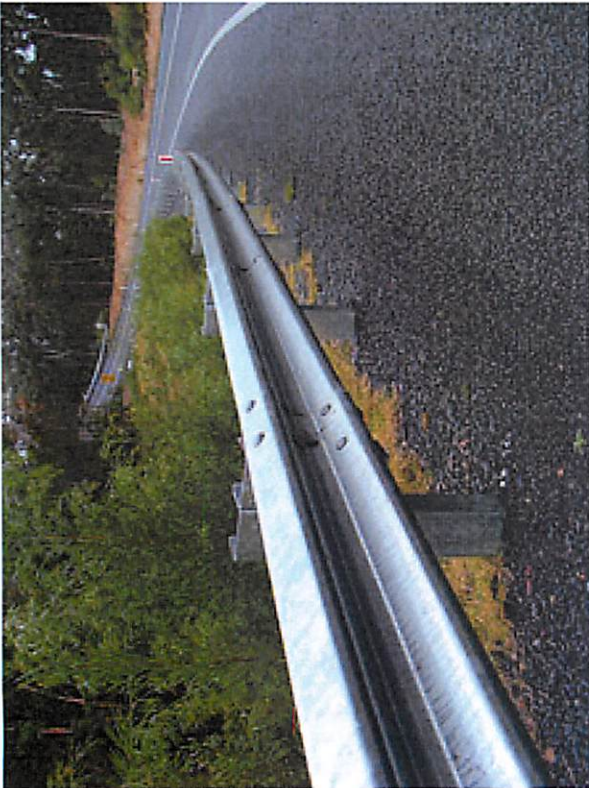
There are other types of decorative guardrail systems that meet the AASHTO/ODOT standards. These decorative systems are relatively expensive. The most commonly used barrier on highways and roads is the functional, but not decorative, "W-beam" guardrail system. Its name comes from the shape of the metal beam used as the rail element of the guardrail, which is supported by wood or steel posts.

“W-Beam Guardrail

The cost of replacing the guardrail/barricade system at the top of the retaining wall will be very expensive. The most inexpensive fix, the "W-beam", would likely reduce the travel lane width on upper 12th Street. This may necessitate converting upper and lower 12th Streets into a one-way couplet. There is sanitary sewer and storm drain pipe systems where supporting posts for the W-beam would be driven into the ground. This will increase the complexity and the cost of the project.

The cost estimate to install the "W-beam" guardrail system is approximately \$112,000 including relocating sewer and drainage pipe. The cost for a decorative concrete barricade system is approximately twice the cost of the "W-beam". This project is not in the current (FYE 2013) budget. The gas tax fund is the typical source for this type of work. We would have to use funds designated for concrete, asphalt and gravel to do the installation and thus forego asphalt patching for the rest of the fiscal year.

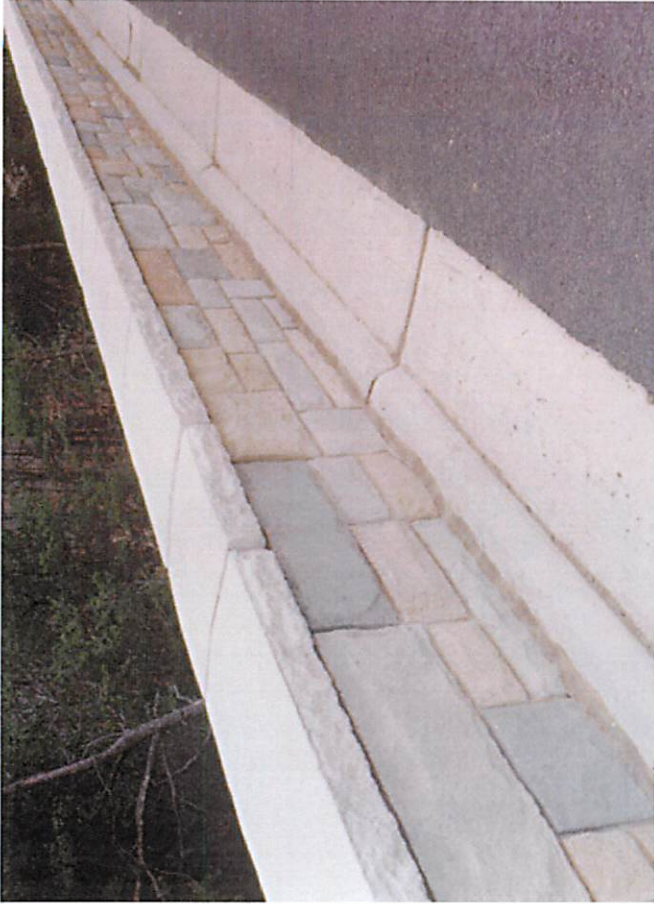
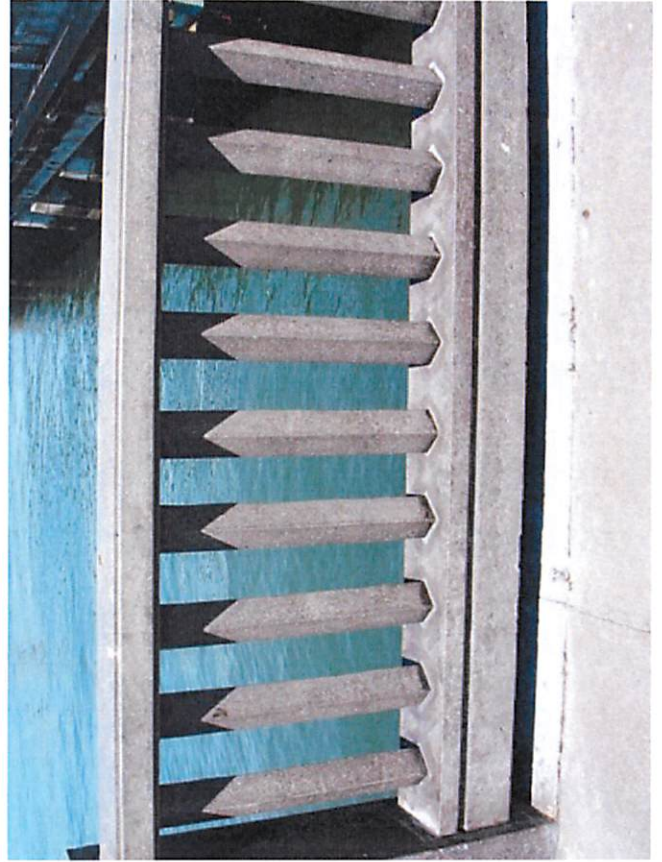
Examples of Decorative Concrete Guardrail
